## Chapter 9

# FIRE BEHAVIOR IN WORLD TRADE CENTER 2

### 9.1 INTRODUCTION

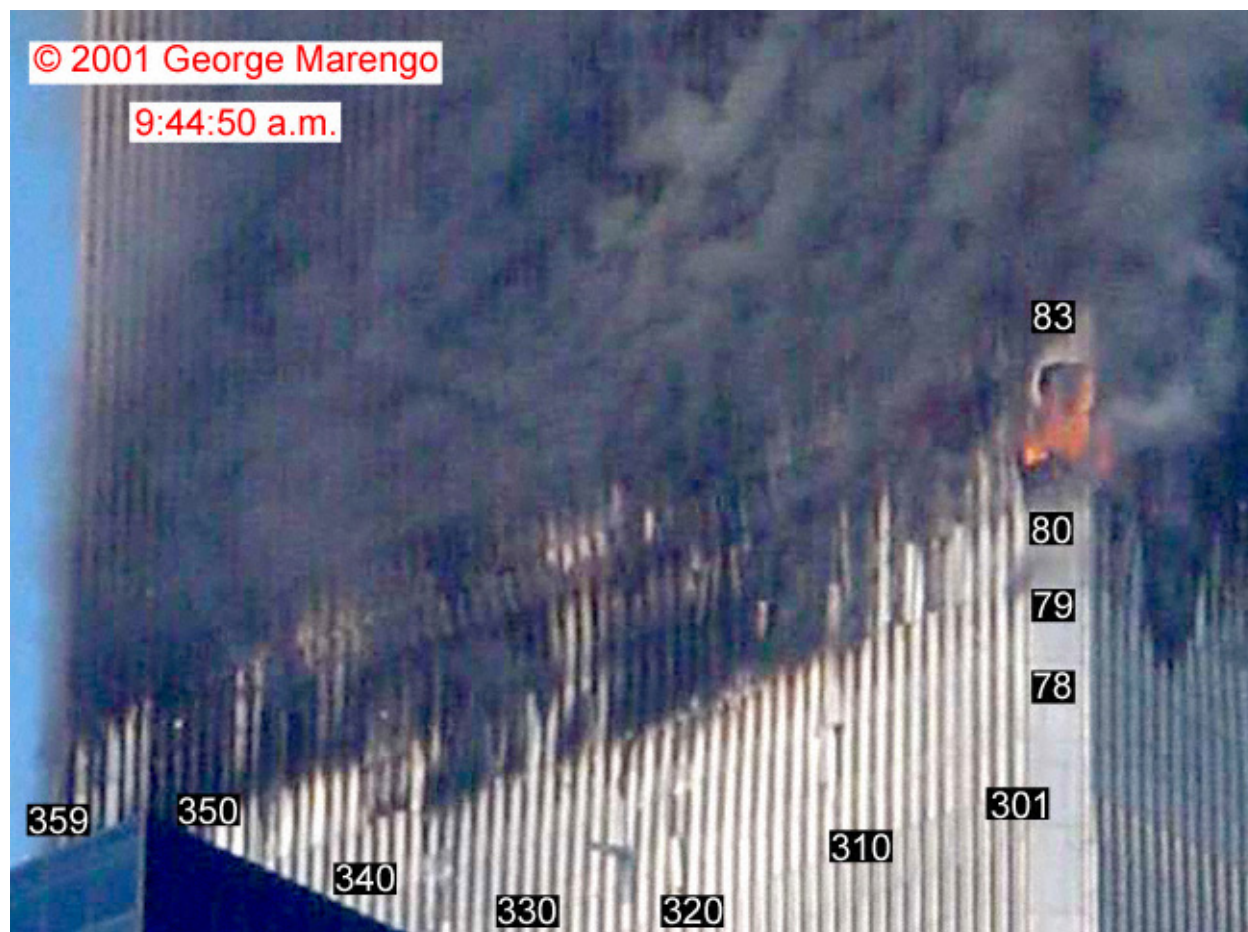
During the periods when the heavy smoke and fires were not present on the east face, its appearance was similar to that seen in Figure 9–48. Occasionally, coordinated puffs of smoke similar to those described earlier were observed coming from windows on the face. Figure 9–59 shows the east face at 9:44:50 a.m. in a photograph shot from the northeast. The amount of smoke coming from lower floors is light, and most of the face is visible. From this angle very little fire is evident, indicating that flames have receded back into the building or died down at many locations on the face. In particular, the heavy flames present near the center of the face in Figure 9–46 and Figure 9–48 seem to have died down by this time. There is evidence for a fire burning on the 82nd floor near the northern edge of the face. Fire had been observed here earlier. The fire in the northeast corner of the 81st floor continued to burn vigorously at 9:44:50 a.m. The bright flame attributed to metal combustion is still evident, but has markedly decreased in intensity.

In Figure 9–59 the columns near the center of the east face on the 80th and 81st floors appear to be bowing inward. A similar feature was identified earlier in Figure 9–46. This photograph provides additional visual evidence that the bowing was actually taking place and for its extent.

**Figure 9-59.** This cropped photograph was shot from the northeast and shows the east face of WTC 2 at 9:44:50 a.m. The original intensity levels have been adjusted, and column and floor numbers have been added.

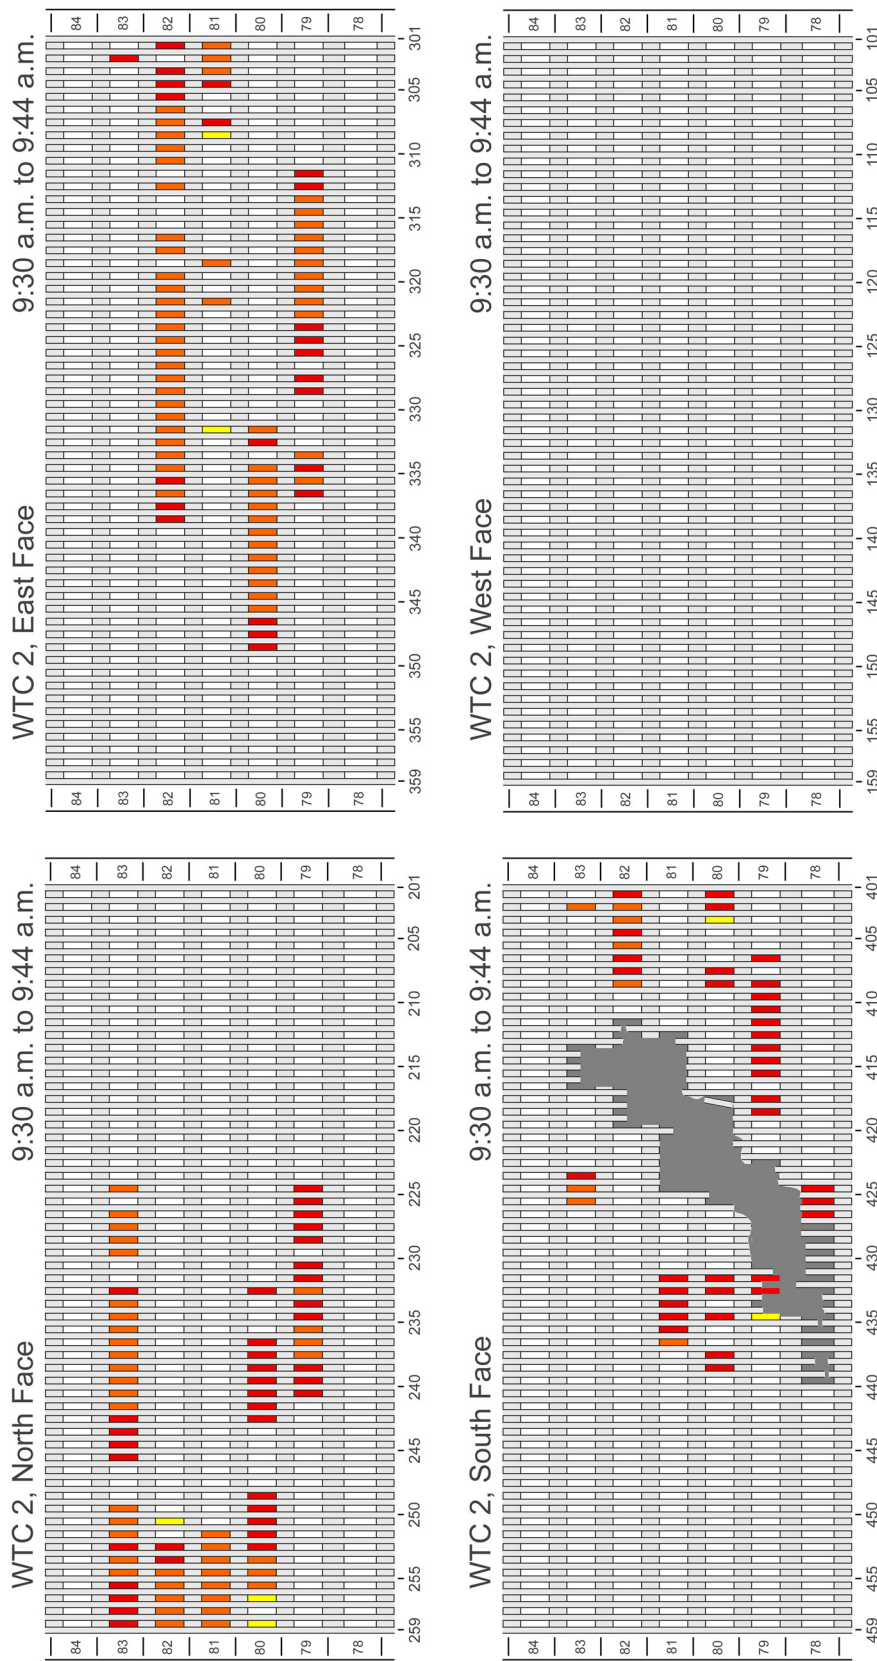
**Figure 9-60. Maps of integrated fire observations between 9:30 a.m. and 9:45 a.m. are shown for the four faces of WTC 2. Colors represent the highest intensity fire observed in a window using the color scale defined in Figure 5-1.**

Fires on the north face that were ignited on piles of debris on the 79th, 81st, and 82nd floors shortly after the aircraft impact, along with a fire that grew somewhat later on a debris pile on the 80th floor continued to burn throughout the period. At 9:29:15 a.m. a fire grew and spread rapidly on the 83rd floor just above the west side of the cold spot. During the period this fire spread to the west in two separate steps, reaching window 83-221 by 9:45:25 a.m. There was also evidence for westward fire spread on the 79th floor. Even though some small fires continued to burn at the periphery of the cold spot, the area continued to be mostly free of fire during the period. The fire behavior on the east face during this period was complex. In addition to the short periods of intense smoke release and burning on the 79th and 80th floors discussed above, a large fire with external flames burned for a short period on the 82nd floor near the center of the face. A fire on the northern edge of the 82nd floor, that had apparently died down earlier, reappeared. The 81st floor fire burning near and in the northeast corner continued to burn throughout the period. An unusually bright flame was observed in the corner that was attributed to metal combustion.

On the south face several fires on various floors around the aircraft impact cavity died down. A small fire was observed on the 83rd floor above the aircraft impact area. A new region of fire, as indicated by the presence of smoke and flame in windows 80-401 to 80-408, burned briefly on the eastern side of the 80th floor. A fire that had first appeared on the 79th floor to the east of the impact cavity around 9:15 a.m. continued to spread toward the east.

There were no indications of fire reaching the west face during the period. Smoke flow from additional open windows above the fire floors was observed and, as for earlier times, possibly caused by people breaking out the glass.

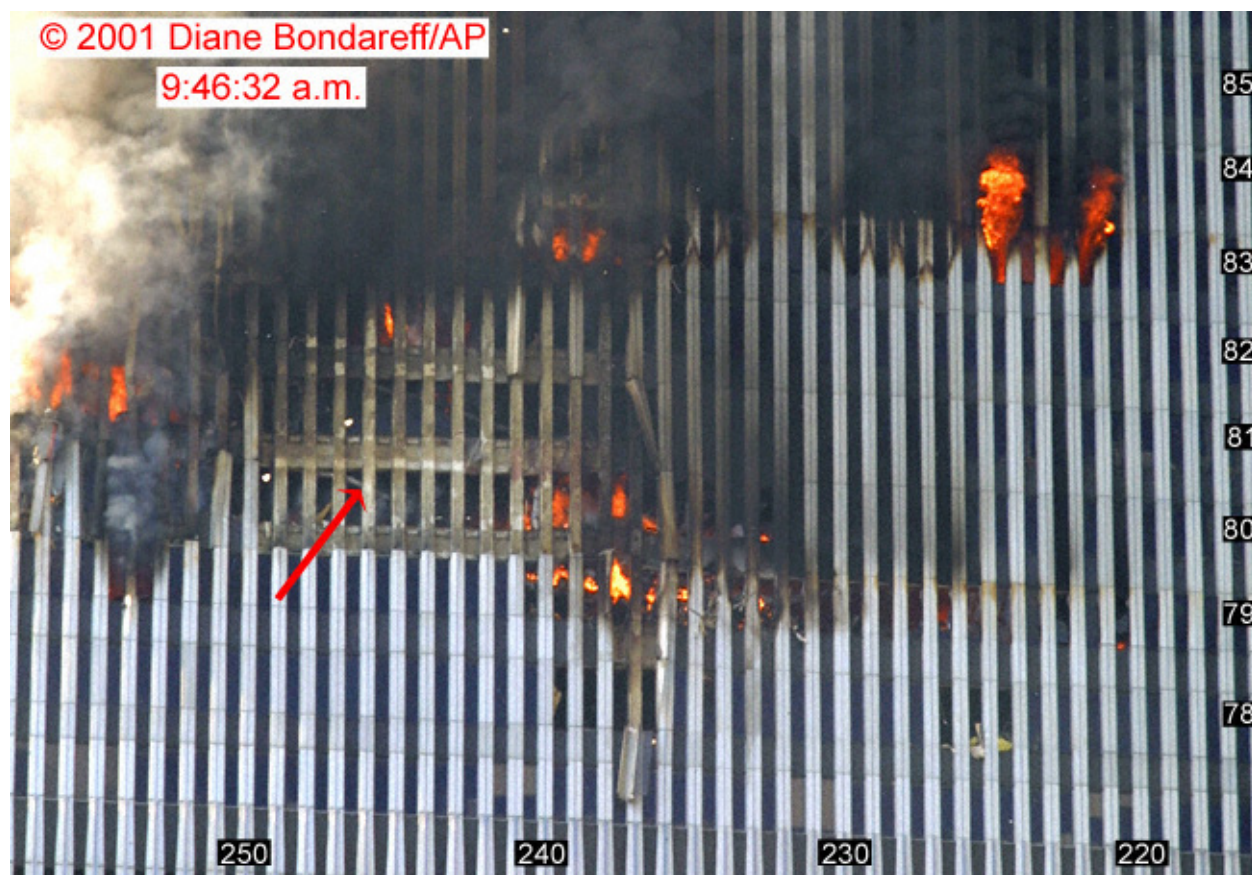
Figure 9–61 shows a photograph of the north face taken at 9:46:32 a.m. It was shot exactly 1 min after the image shown in Figure 9–53. While the fire distributions look similar in the two photographs, there has been a significant change. At 9:46:32 a.m. a substantial fire is visible near the center of the cold spot on the 82nd floor. Prior to this time, there had been no indication of a fire at this location. The photograph in Figure 9–61 was shot with high resolution and magnification. It is possible to enlarge it substantially. Two blow-ups of areas in the image are shown in Figure 9–62 and Figure 9–63. In the blow-ups the intensities have been adjusted to highlight darker regions.

**Figure 9-61.** This cropped photograph shows the north face of WTC 1 at 9:46:32 a.m. The intensity levels have been adjusted, and column and floor numbers have been added. The arrow indicates a hanging object visible through windows on the 80th floor.

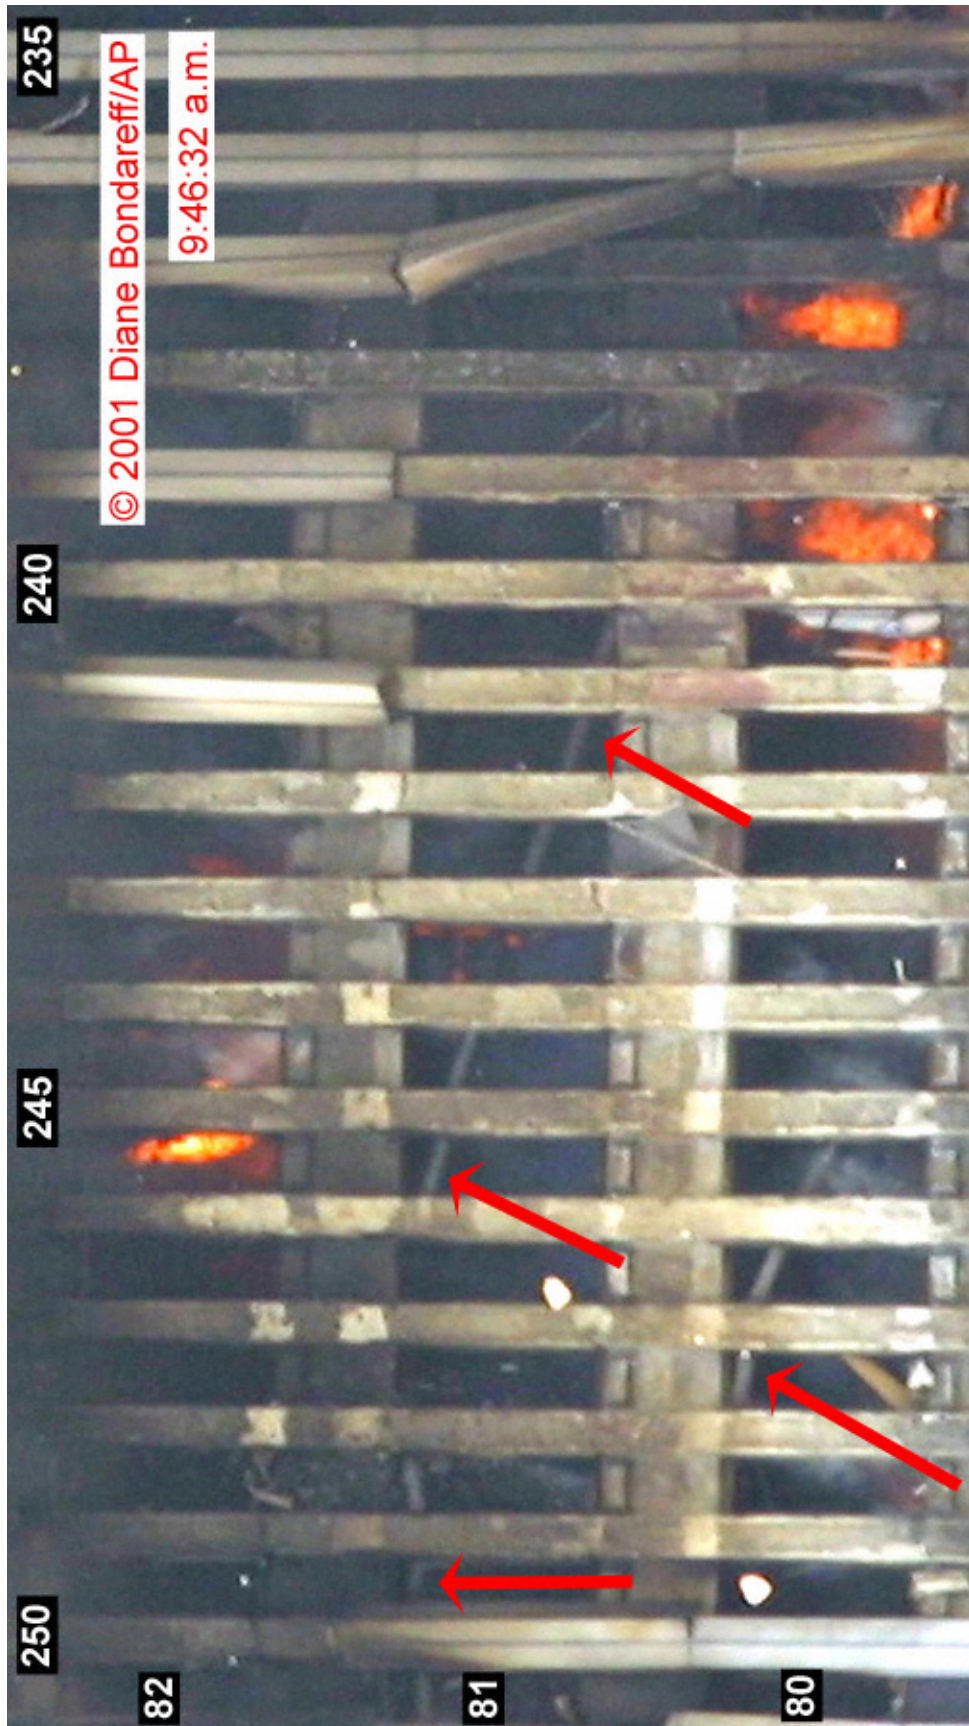
Figure 9–62 shows an enlargement of the area of the north face encompassing the cold spot. Here it can be seen that the fire that has grown on the 82nd floor consists of the bright flame visible through window 82-245 and duller flames that appear to be further back from windows 82-242 to 82-244 and 82-246. There is no indication of where this fire spread from. A hanging object, marked with arrows, is visible through the open windows on the floor immediately below the fire. This object was not immediately apparent in Figure 9–61, but became visible when the image intensities were further adjusted to highlight dark areas. This object was observed at the same location at 9:42:31 a.m. in the image shown in Figure 9–51 and Figure 9–52. Note that there is a section of the object visible near the tops of windows 81-248 to 81-250 that was not clear in Figure 9–52.

Closer inspection of Figure 9-62 shows that small dull-colored flames are visible on the 81st floor through windows 81-243 and 81-244 at the level of and above the hanging object. This suggests that a fire is burning on top of the object. It is possible that this fire is burning at the base of a debris pile that is also providing fuel for the fire visible immediately above on the 82nd floor. If true, this means that the hanging object is most likely a portion of the 82nd floor that has broken away from the spandrel at the base of the 82nd floor and settled to its current location from above.

The hanging object visible in Figure 9-62 on the 80th floor is also in the same position as observed at 9:42:31 a.m. In this closer view it has a very similar appearance to the hanging object on the 81st floor. Therefore, it appears to be a portion of the 81st floor slab that has separated from the spandrel and dropped down from above.

The fire that had been burning at the lower left-hand corner of the cold spot since before 9:15 a.m. is still burning vigorously in Figure 9-62. This long burning time suggests that the fuel is a large debris pile since typical office fuels should have burned out by this time. It may be that the 80th floor slab is missing in this area and that the fires visible on the 79th and 80th floors (see Figure 9-61) are actually burning on the same pile of debris. There is weak evidence to support such a conclusion. The arrows in Figure 9-63 have been added to highlight what may be a hanging object in windows 79-229 to 79-233 on the 79th

Figure 9-62. This image is enlarged from the photograph included in Figure 9-61 and shows the cold spot on the north face of WTC 2 at 9:46:32 a.m. The intensities have been adjusted to enhance dark areas, and column and floor numbers have been added. The arrows point to hanging objects visible on the 80th and 81st floors.

The contrast available in Figure 9–62 and Figure 9–63 is sufficient to identify whether or not glass has been broken out of windows. In Figure 9–62 the only window that is closed is window 81-235. In Figure 9–63 several windows are visible on the 79th floor in which glass has been partially removed, presumably due to heating from the nearby fire. The westernmost of these is window 79-220. A small spot fire is visible at the base of this window. On the 80th floor the westernmost open window is window 80-232. A small fire is also present in this window. The glass in the window to the immediate left, window 80-233, appears to be intact. Several open windows are visible on the 78th floor. These have been previously identified as having been broken during the aircraft impact and subsequent fireballs.

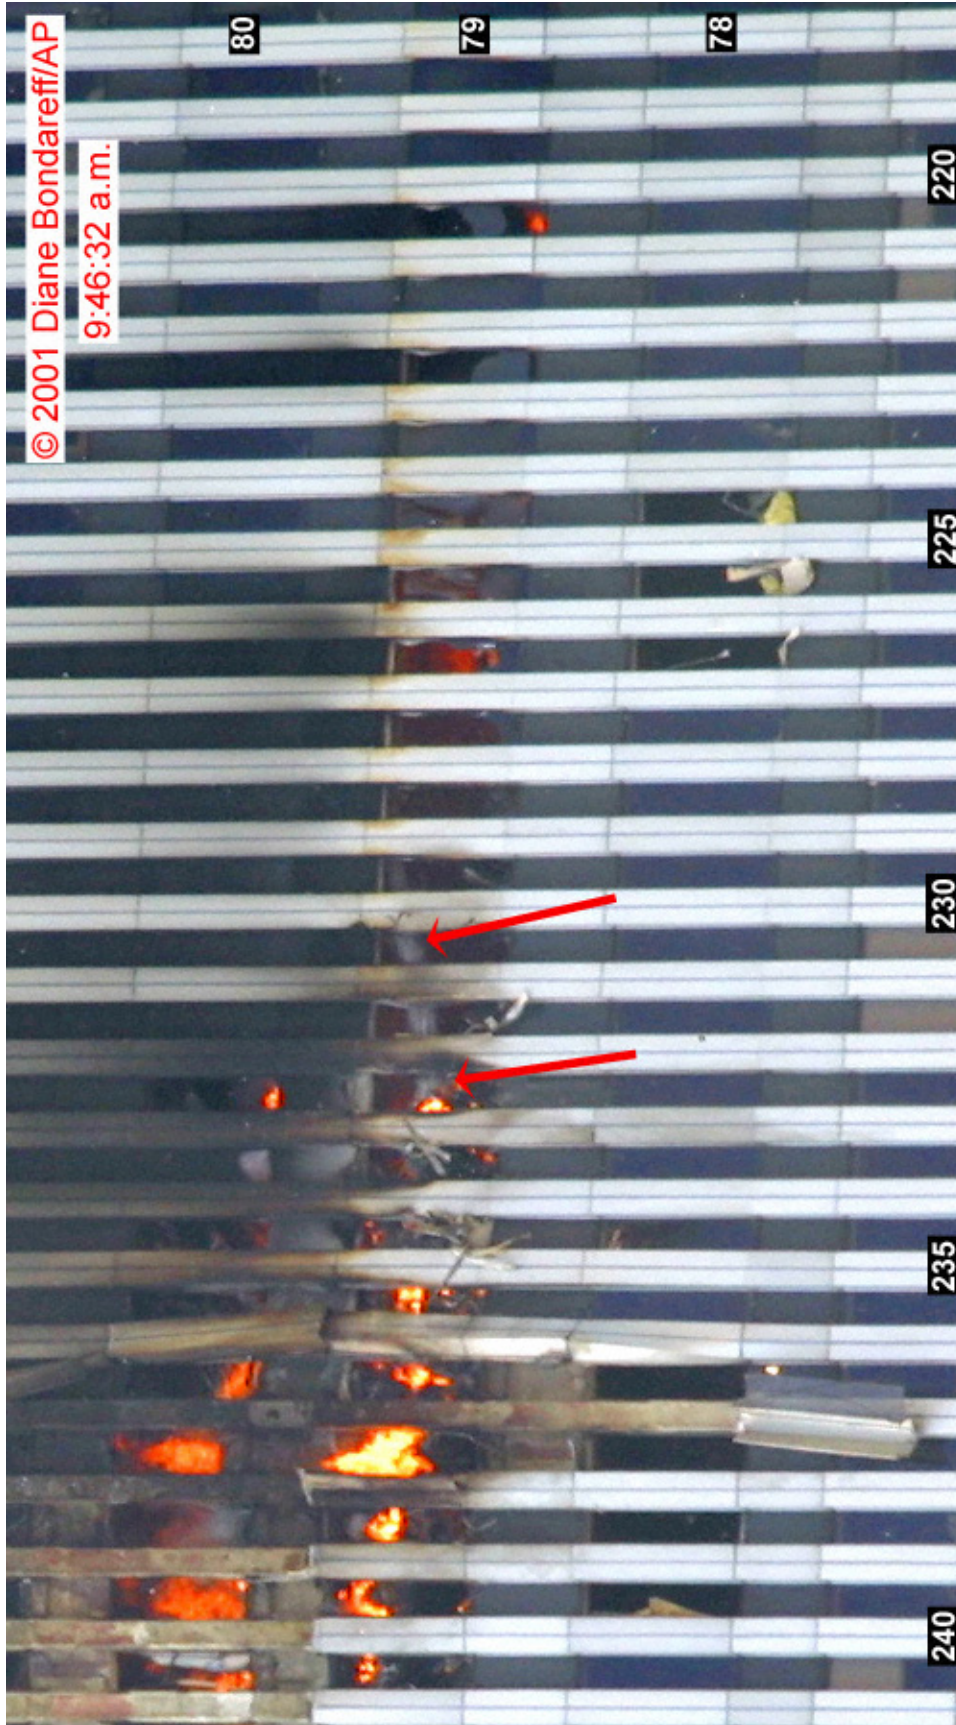
Figure 9-63. This image is enlarged from the photograph included in Figure 9-61 and shows fires near the center of the north face of WTC 2. The intensities have been adjusted to enhance dark areas, and column and floor numbers have been added. The arrows point to a hanging object visible on the 79th floor.

floor. The appearance of the object in these windows is somewhat different than those observed elsewhere on the north and east faces of WTC 2. This introduces some uncertainty into its identification as one of the hanging objects.

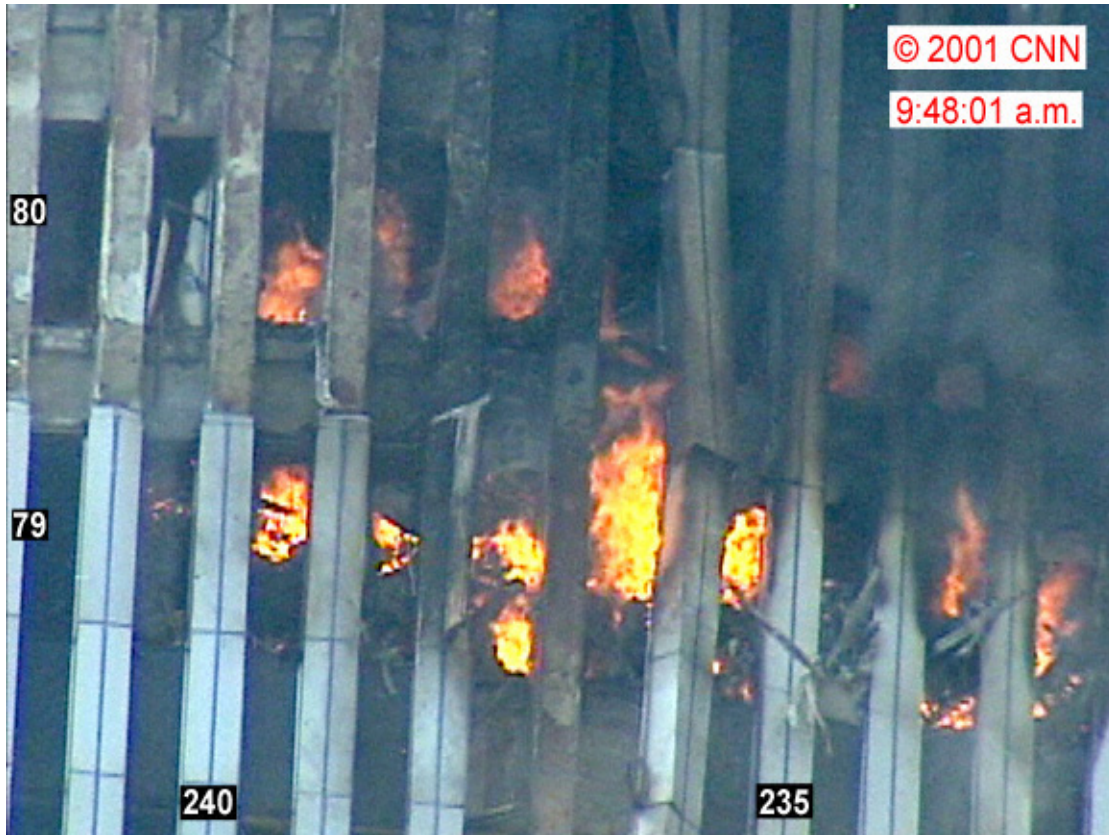
A close-up image of the burning debris pile on the 79th floor is shown in Figure 9–64. This image is a video frame that was captured at 9:48:01 a.m. The bulge in the spandrel at the base of the 80th floor is pronounced. Despite the degree of detail available in the image, it is not possible to determine whether the fires visible on the 79th and 80th floors are burning on a single large pile of debris, i.e., the intervening floor slab is missing, or there are two separate fires on the two floors.

**Figure 9-64. This close-up image of the north face of WTC 2 was captured from a video recorded at 9:48:01 a.m. The intensity levels have been adjusted, and column and floor numbers have been added.**

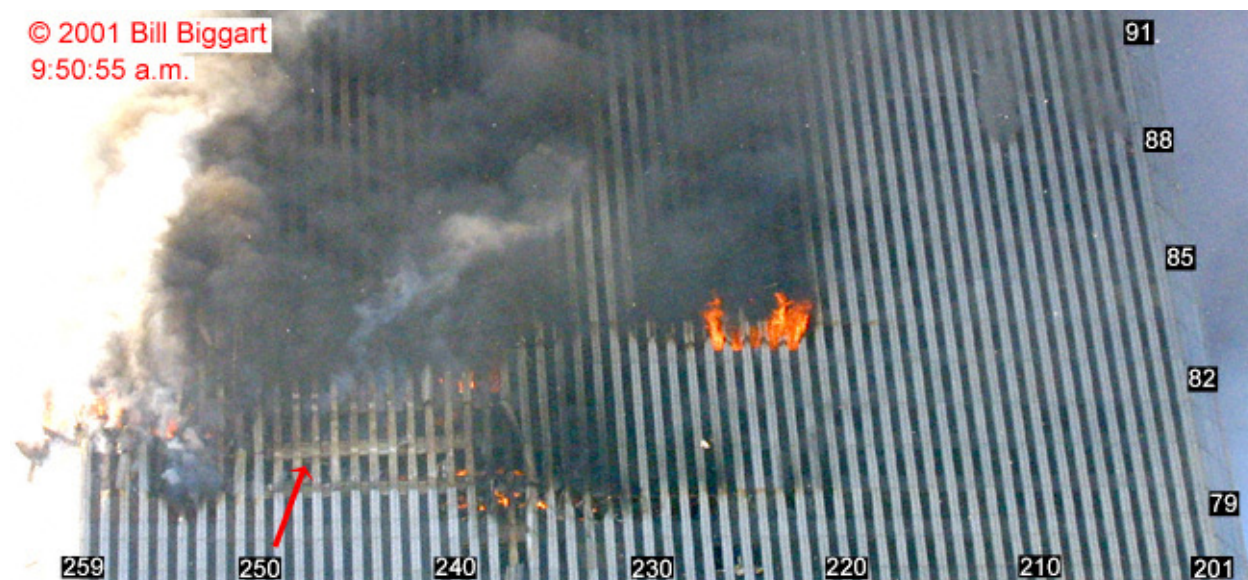
An image of the north face of WTC 2 taken at 9:50:55 a.m. is shown in Figure 9–65. Comparison with Figure 9–61 shows that some changes occurred in the approximately 4½ min between the two photographs. The intense fire burning on the 83rd floor moved west one window. A video shows that fire appeared in window 83-225 at 9:49:11 a.m.

The fire that was visible in the cold spot in the earlier photograph on the 82nd floor has spread over more windows. It is now visible in windows 82-247 to 82-244. The small flames observed earlier one floor down in window 81-243 are still visible, but a more substantial fire has grown just to the west, and flames are now visible in windows 81-239 and 81-240. The fire on the west side of the cold spot on the 80th floor has died down somewhat.

The fire on the eastern edge of the 81st floor seen in Figure 9-65 continues to burn on the debris pile in this area. The appearance of the fire that had earlier spread west on the 79th floor has not changed markedly. Earlier it was mentioned that windows on the 89th floor possibly had been broken open by people at windows 89-201 to 89-203 and window 89-208. Light smoke flows are visible coming from these windows in Figure 9-65.

The hanging object on the 80th floor is just visible in this photograph as indicated by the arrow.

**Figure 9-65.** This cropped photograph shows the north face of WTC 2 at 9:50:55 a.m. The original has been rotated and enhanced by adjusting the intensity levels. Column and floor numbers have been added. The arrow points to a ganging object visible through open windows on the 80th floor.

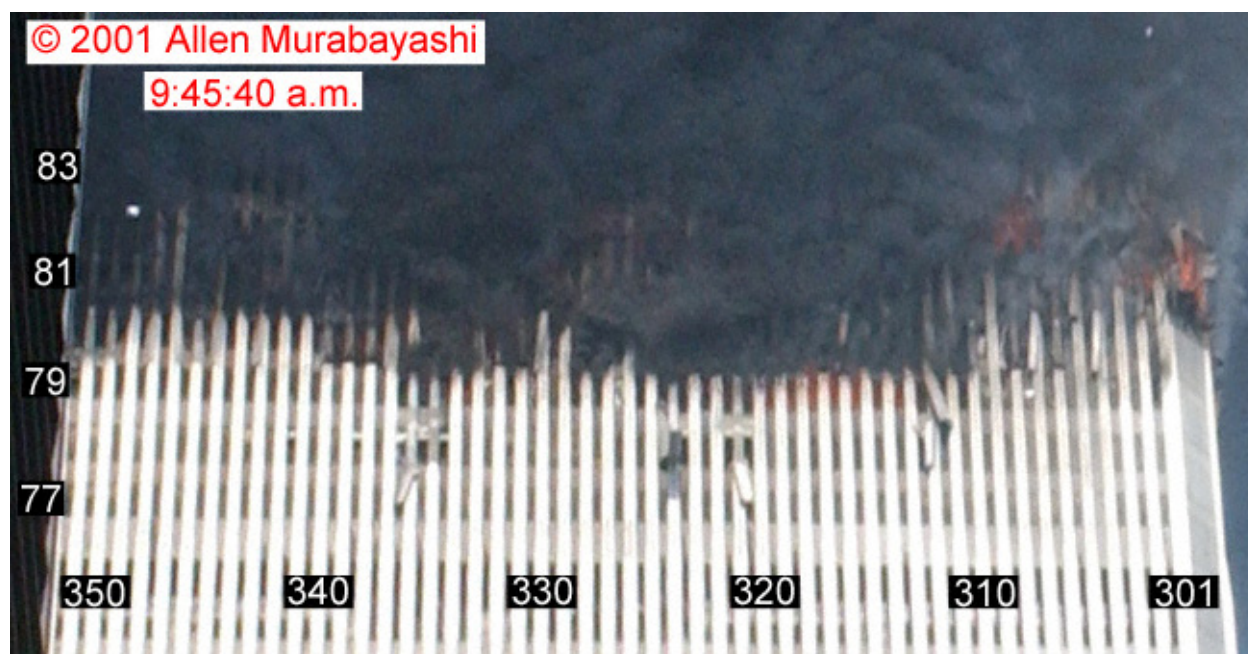
Starting around 9:44:58 a.m. there was another period during which heavy smoke flows came from numerous open windows on the 79th and 80th floors of the east face. This release lasted until approximately 9:46:05 a.m. Figure 9-66 shows an image recorded during this smoke release at 9:45:40 a.m. Comparison with Figure 9-43 and Figure 9-58 indicates that the amount of smoke flow and visible flame are much less than observed during the three similar earlier events. Nonetheless, the smoke flow obscured much of the face, and videos show that intermittent flames appeared outside of some windows. Near the end of this smoke release episode, there were two large pressure pulses at 9:45:57 a.m. and 9:46:01 a.m. that pushed large amounts of smoke out of windows on the 79th and 80th floors.

In Fig. 9-66 flames are visible on the 79th floor between windows 79-313 and 79-319 and are coming from window 82-306 to window 82-308 on the 82nd floor. At 9:38:22 a.m. (see Fig. 9-48) fires were observed at the same locations. The earlier photograph was shot in between the periods of heavy smoke flow and external flaming. This shows that these fires are well established and are not associated with the periods of heavy smoke flows and external burning. The fire in the 81st floor northeast corner continued to burn at 9:45:40 a.m.

**Figure 9-66.** This cropped photograph shows the east face of WTC 2 at 9:45:40 a.m. The image has been rotated, and the intensity range has been adjusted. Column and floor numbers have been added.

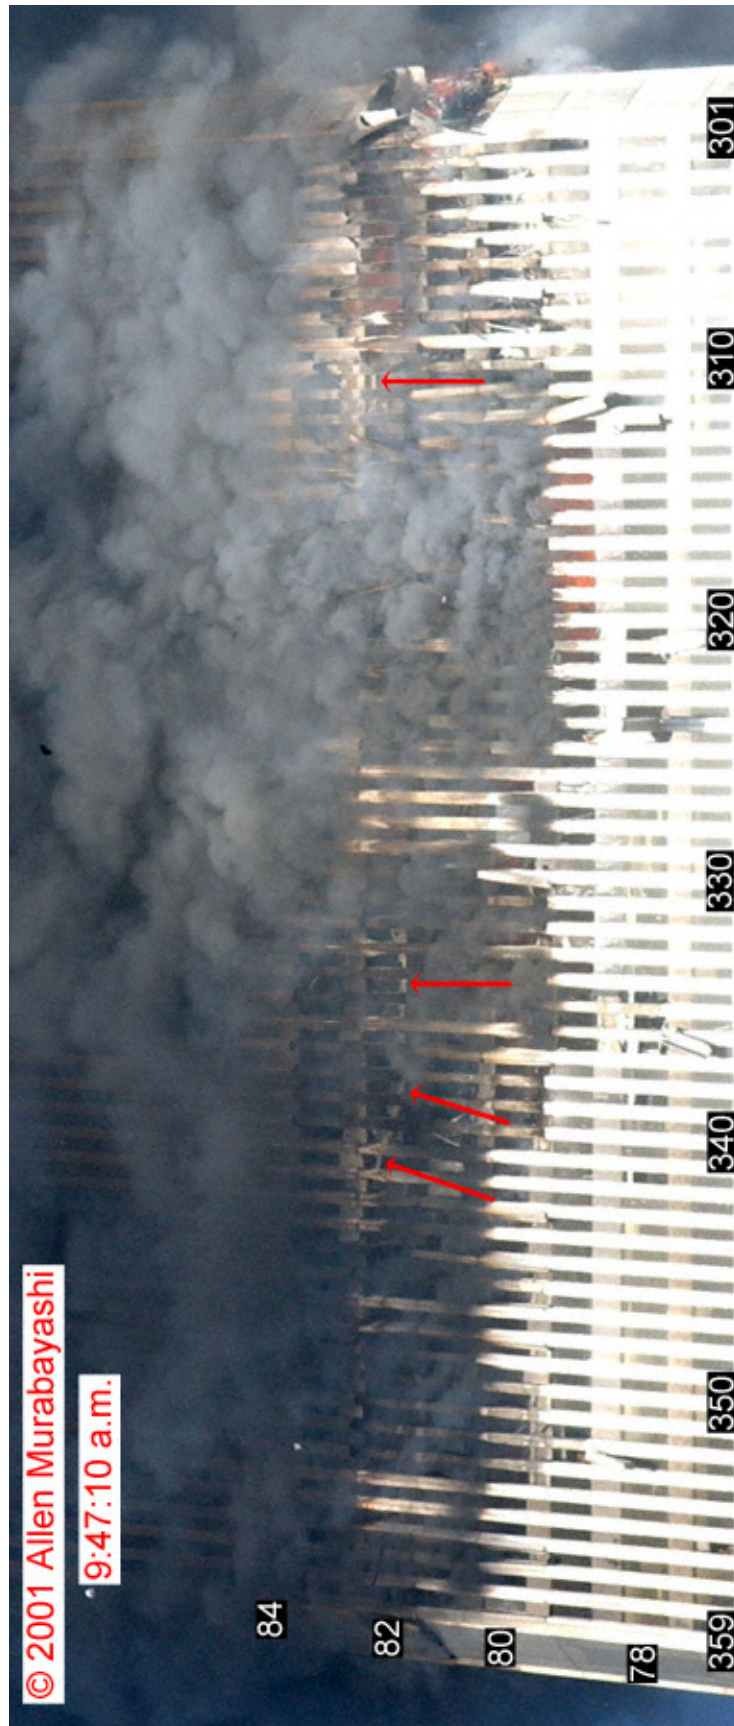
Figure 9–67 shows a higher resolution photograph of the east face taken 1½ min after Figure 9–66 at 9:47:10 a.m. The smoke has cleared up, and it is now possible to see many more windows at the south side of the face on the 80th and 81st floors, as well as higher up on the face. A substantial fire, visible in windows 79-313 to 79-320, continues to burn on the 79th floor. Flames are also present in windows 82-303 to 82-307. The fire on the 81st floor is isolated to the first couple of windows along the northern edge of the east face and the pile of debris in the northeast corner. At this time flames were not visible elsewhere on the east face.

Figure 9-67. This cropped photograph of the east face of WTC 2 was taken at 9:47:10 a.m. The original has been rotated slightly, and the intensity levels have been adjusted. Column and floor numbers have been added. The arrows highlight a hanging object that is visible through open windows on the 82nd floor.

In Figure 9-67 heavy smoke was flowing from windows 79-314 to 79-320 on the 79th floor, and flames were extended from a number of these windows. In Figure 9-80 relatively light smoke is coming from windows 79-319 to 79-321, and there is no indication of external flaming. Apparently, the fires present in this area roughly 5½ min earlier have died down considerably. Carets at the tops of the covers for columns 79-312 to 79-324 indicate the relative local intensities of the fire that burned in this area earlier. In the photograph taken at 9:47:10 a.m. (Figure 9-67) the most intense burning at the northern edge of the 82nd floor was in windows 82-306 and 82-307. At the later time flames are only visible in window 82-303. On the other hand, the flames on the northern edge of the 81st floor are clearly more intense at the later time. Overall, the number and intensities of the fires on the east face appear to be at their lowest levels since the aircraft impact 50 min earlier.

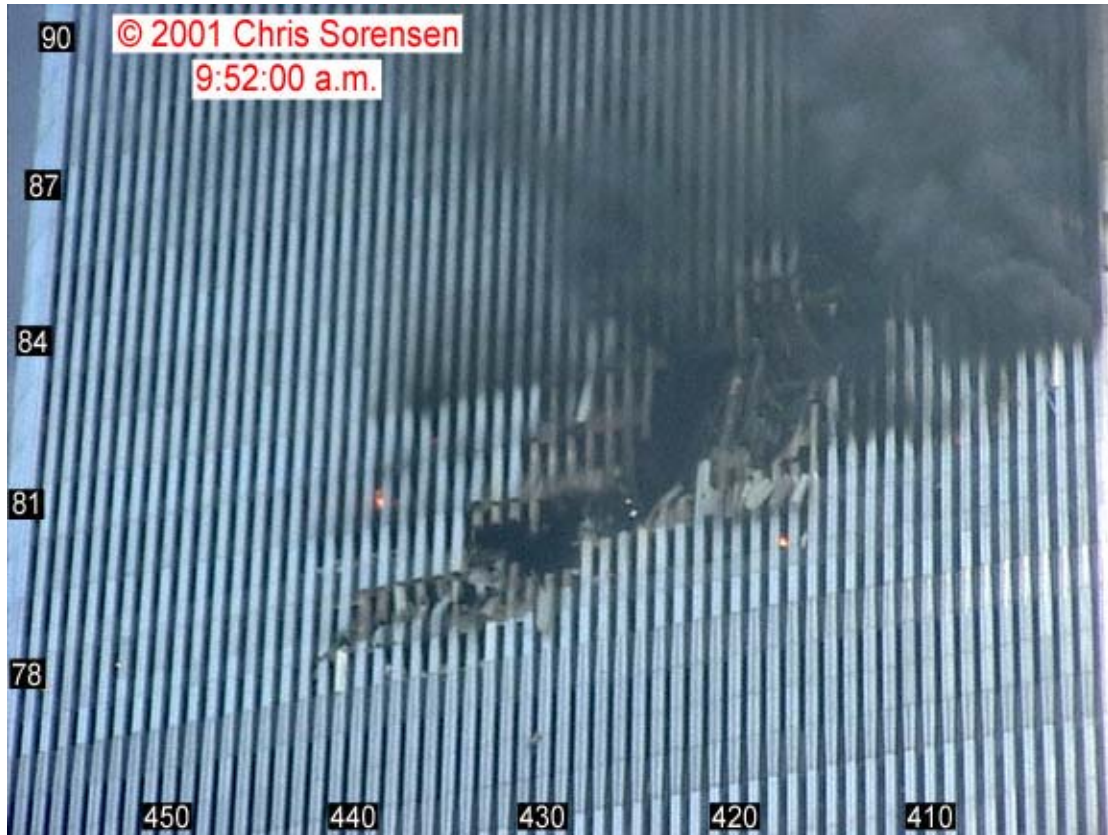
Figure 9–68 shows a view of the south face recorded at 9:52:00 a.m. It is taken from a video shot from a location to the southeast of the tower. Several small fires are visible on the 78th (window 78-418), 79th (window 79-408), 80th (windows 80-438 and 80-439), and 81st (window 81-436) floors. Heavy smoke is flowing from windows near the eastern edge of the 80th floor. There is a stream of smoke coming from the 81st floor in the same area. At this time the smoke flow from other areas of the face was relatively light. Markings on column covers near the tops of windows indicate that smoke had earlier come from windows on the 79th, 80th, and 81st floors just to the west of the aircraft impact cavity. The smoke band on the 81st floor, which extends from window 81-431 to 81-439, is the darkest. The presence of this smoke band is consistent with the recent smoke releases observed from this floor.

**Figure 9-68.** This view of the south face of WTC 2 was taken from a video recorded at 9:52:00 a.m. The intensity levels have been adjusted, and column and floor numbers have been added.

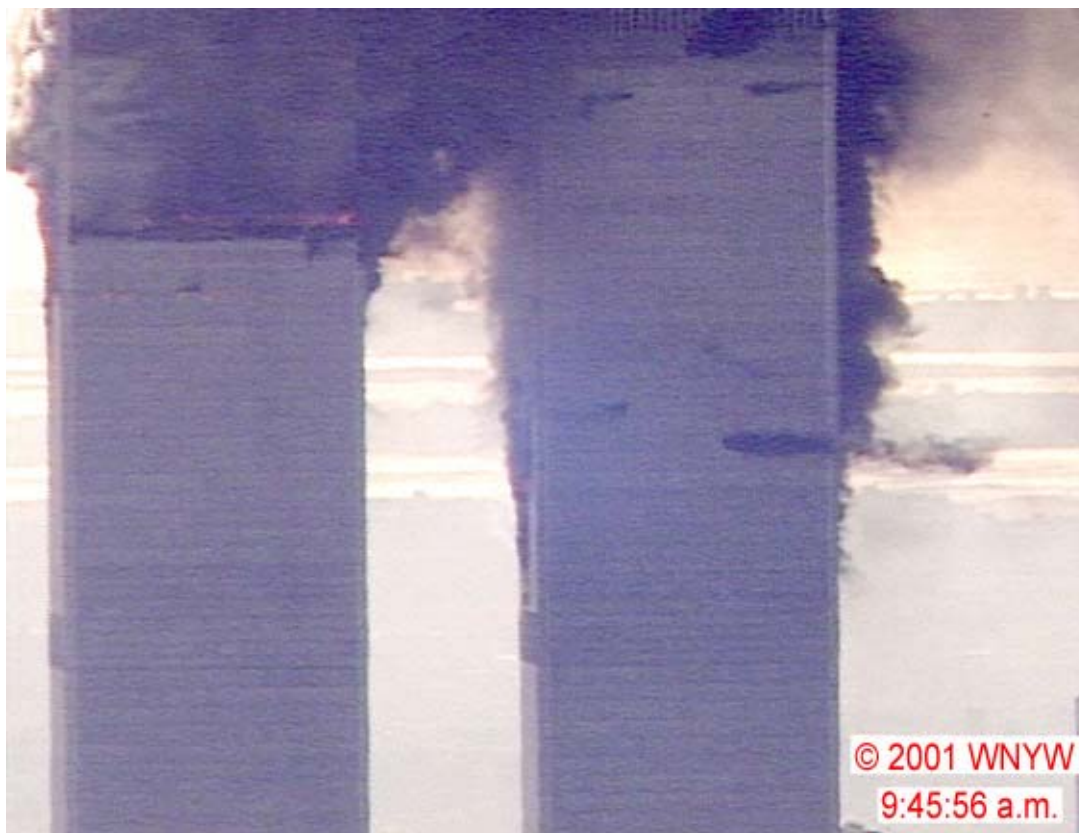
Figure 9-69 shows a long-distance view of the west face of WTC 2 at 9:45:56 a.m. Smoke streams are coming from open windows on several floors, many at the same locations observed in earlier images. The discussion associated with Figure 9-57 refers to open windows on the 84th, 86th, 88th, 91st, 105th, and 107th floors. The three lower smoke trails visible in Figure 9-69 are coming from the windows previously identified on the 86th, 88th, and 91st floor. Closer to the top of the face, three separate smoke trails are visible on the 95th floor. Slightly closer views of the area show that the northern most stream is coming from window 105-148, which is the location visible in Figure 9-57. The other two streams are from near windows 105-116 and 105-140. These two smoke flows were observed to be intermittent in videos of the west face. They were detected briefly as early as 9:43:45 a.m. The heavy smoke flow from the 107th floor observed earlier is prominent in Figure 9-69. The light smoke coming from the southern edge of the mechanical equipment room on the 108th floor is also visible.

**Figure 9-69.** This west view of WTC 1 and WTC 2 is a frame captured from a news helicopter video at 9:45:56 a.m. The intensity range has been adjusted.

Figure 9–69 provides an indication of the complexity of the wind patterns present on the west face of WTC 2 on September 11, 2001. The smoke trails on the lower floors are flowing in opposite directions. Around this time, the heavy smoke coming from windows on the 86th floor was observed streaming across the south face of the tower. A similar flow pattern is evident in Figure 9–57. Videos show that at other times the smoke from these windows would reverse direction and actually flow toward the north. Figure 9–42 shows an example of this flow at 9:34:19 a.m. As discussed in Section 4.1, these complex wind patterns developed because WTC 2 was on the leeward side of WTC 1, which shielded it from the direct impact of the ambient wind and created complex flow patterns that interacted with WTC 2.

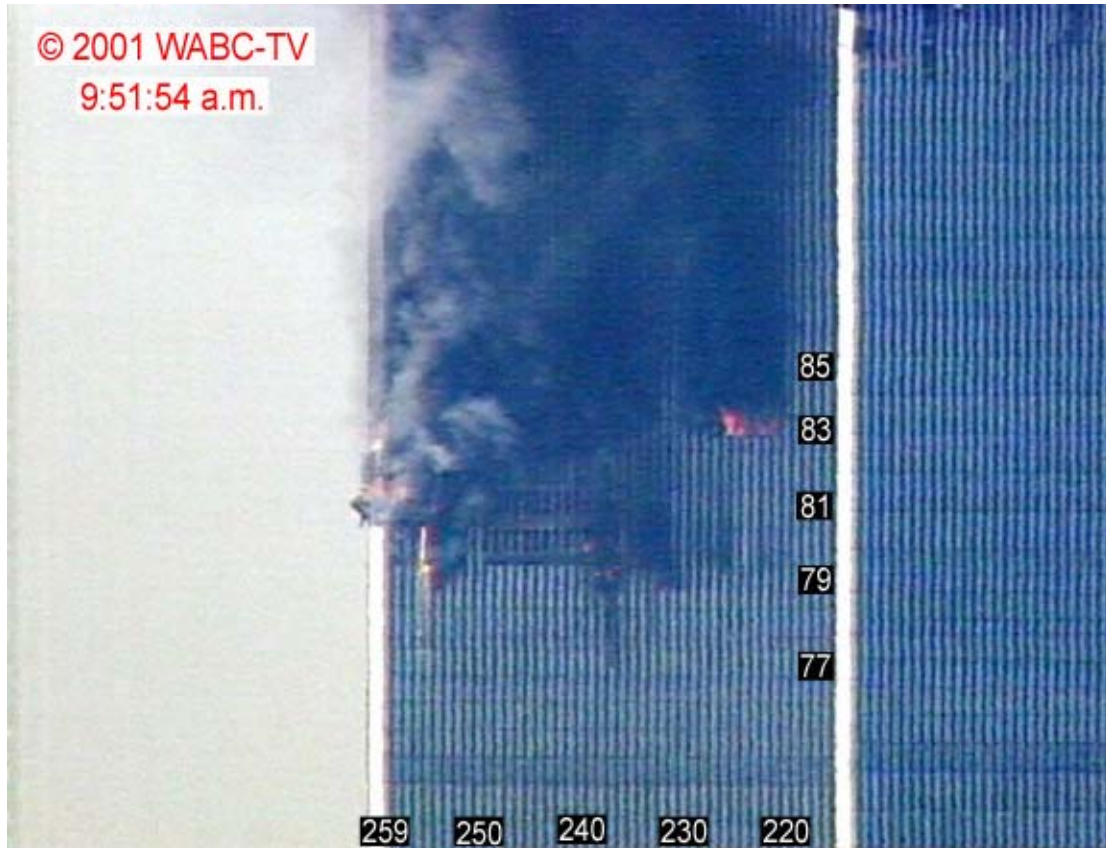
At 9:51:51 a.m. puffs of smoke and/or dust were expelled from open windows on the 79th, 80th, and 81st floors on the north face of WTC 2 near the east edge. These included windows 79-253 and 79-254, 80-257 and 80-258, and 81-254. Almost simultaneously, smoke was pushed from windows on the 79th and 80th floors of the east face. Just over a second later, a bright spot appeared at the top of one window, 80-255, on the 80th floor, and a glowing liquid began to pour from this location. As it fell, the glowing liquid struck the base of window 80-255 and splashed before falling further. Figure 9–70 shows a frame captured from a video at 9:51:54 a.m. in which the falling liquid and the splashing can be seen. This liquid flow lasted approximately 4 s before subsiding. After the flow stopped, the glowing spot was still visible at the top of window 80-255.

**Figure 9-70. This image of the north faces of WTC 1 and WTC 2 was captured from a video recorded at 9:51:54 a.m. The intensity levels have been adjusted, and column and floor numbers have been added to WTC 2.**

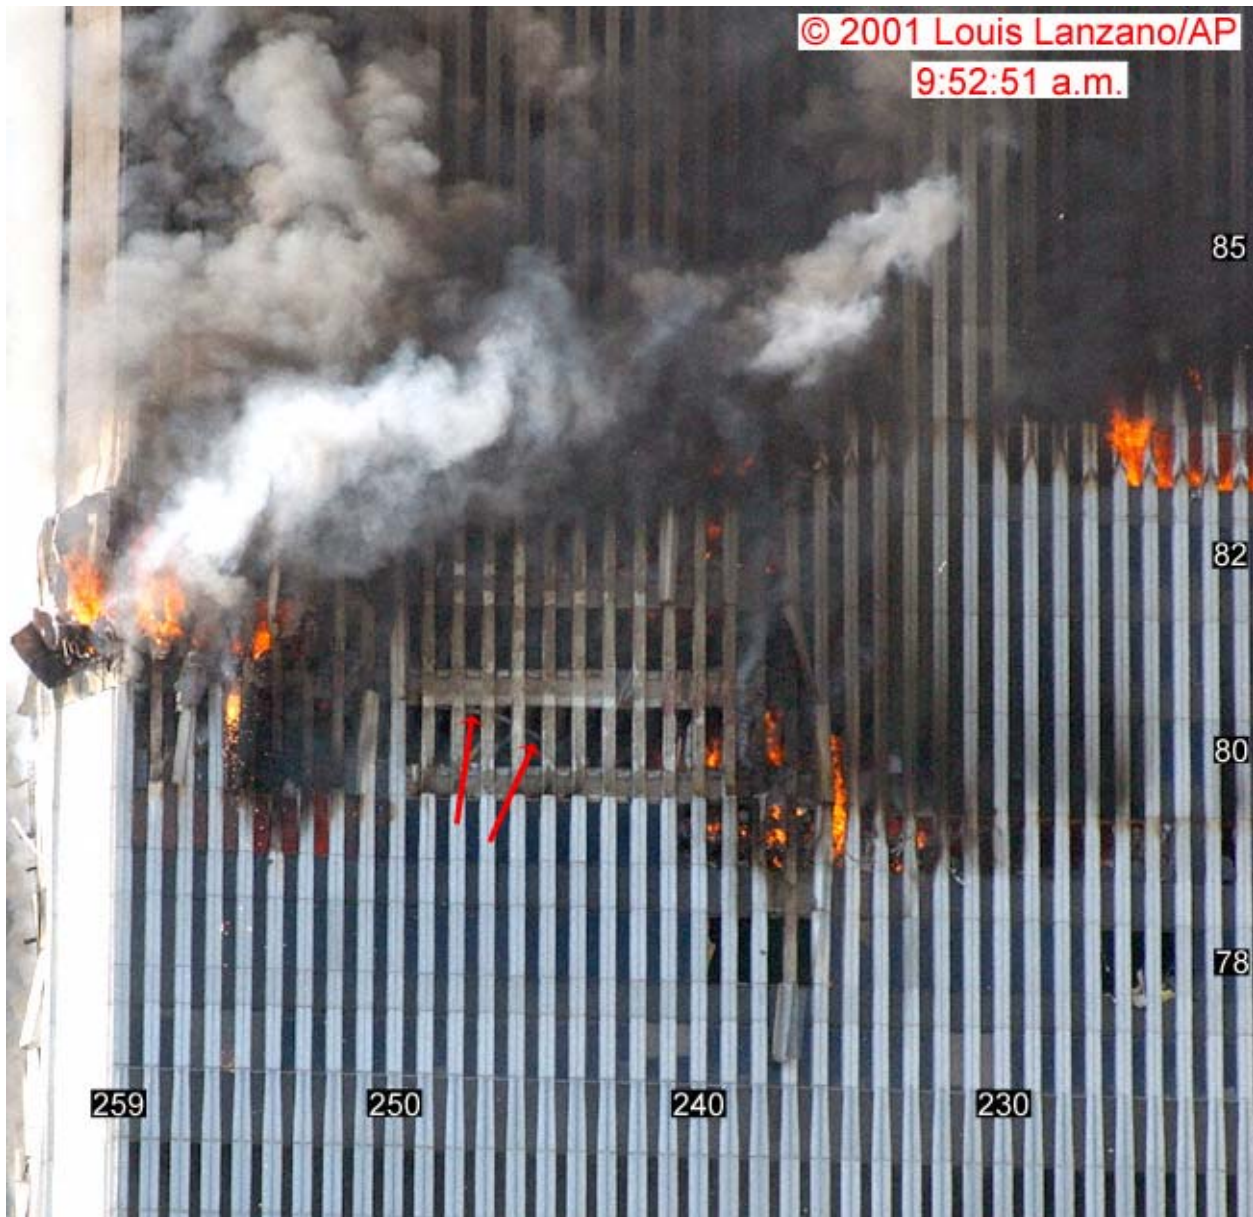
A high-resolution photograph of the north face shot at 9:52:51 a.m., i.e., just 4 s after the start of the first of the three pressure pulses, is shown in Figure 9–71. The white cloud in the photograph is the rising dust and/or smoke that was pushed from windows on multiple floors during the pressure pulse. Blow-ups of the area around window 80-255, which is the location on the 80th floor where the molten material poured from, and the cold spot are shown in Figure 9–72 and Figure 9–73, respectively.

**Figure 9-71.** This cropped photograph shows the north face of WTC 2 at 9:52:51 a.m. The image has been enhanced by adjusting the intensity levels, and column and floor numbers have been added. The arrows highlight a hanging object visible through open windows on the 80th floor.

As seen in Figure 9–71, the fire located on the 83rd floor in windows 83-221 to 83-225 continued to burn vigorously at 9:52:51 a.m. Recall that flames first appeared in this area at 9:42:53 a.m. Other images available around this time show no apparent additional spread of this fire towards the west. Carets are visible on many of the aluminum column covers between columns 83-222 and 83-236. Many of these carets are near the base of the windows, providing an indication for the intensity of the flames that were present at these locations earlier.

There appears to be a small fire burning on the 84th floor in window 84-223. This is an interesting observation because it is likely that this fire was ignited by flames coming from below, possibly through a window opened by the heat coming from the 83rd floor. If so, this would represent the clearest example of upward flame spread by an external pathway observed on September 11, 2001. On the 79th floor the fire burning on the debris pile is still visible in windows 79-232 to 79-239. The fire on this floor that had earlier spread to the west has died down and is no longer visible.

Smoke is visible coming from multiple windows near the western edge of the face on the 88th and 93rd floors. These windows have previously been identified as possibly having been broken open by people. Clearly, smoke is continuing to pass up through the core of the tower to these floors.
